THE INSPECTION CONNECTION

Report # : 3717-11 Sample

Subject Property
71717 Double Eagle Drive
Rancho Mirage, CA 92270

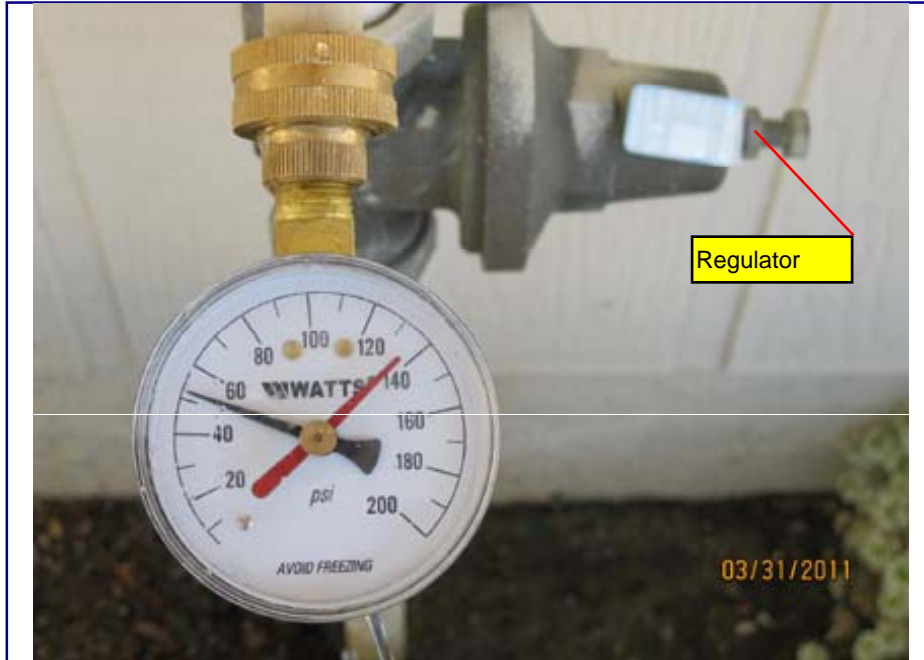
Picture 1

Water pressure is measured at 55 psi, which is ideal for this residential application.

Pressure may be set up if desired from regulator at right background.

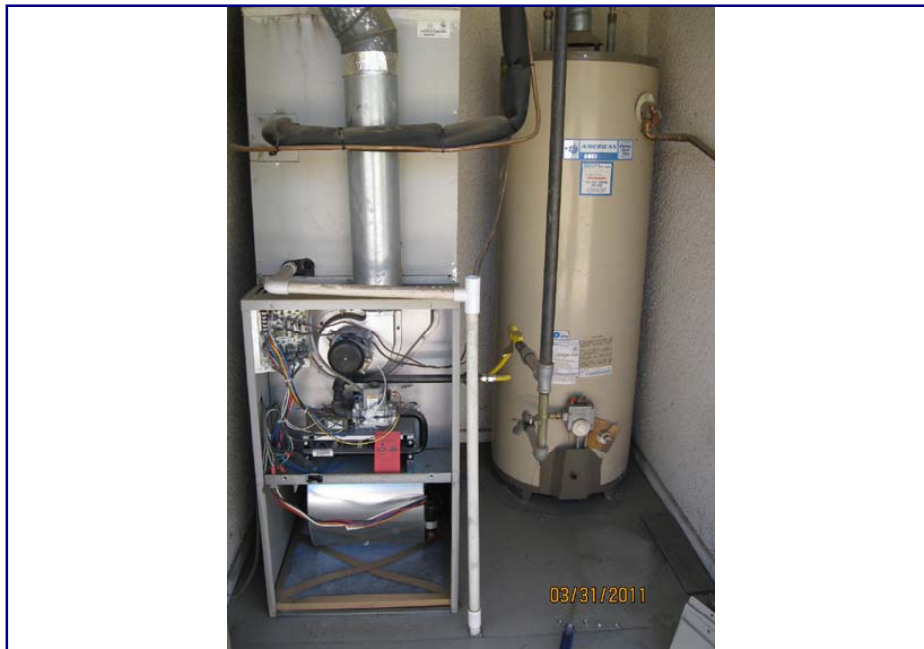
Picture 2

Comments: **Seismic bracing is required to be installed at top 1/3 and bottom 1/3 of tank body # A. Recommend installation as necessary by licensed plumbing contractor. See photo # 2. Tank # B is equipped with circulation pump system, which operates as designed.**

72,000 btu furnace is installed to conform with prevailing standards and operates as designed at time of inspection in both heat and chill modes.

Seismic bracing is required to be installed at top 1/3 and bottom 1/3 of water heater tank body. Recommend installation as necessary by licensed plumbing contractor.

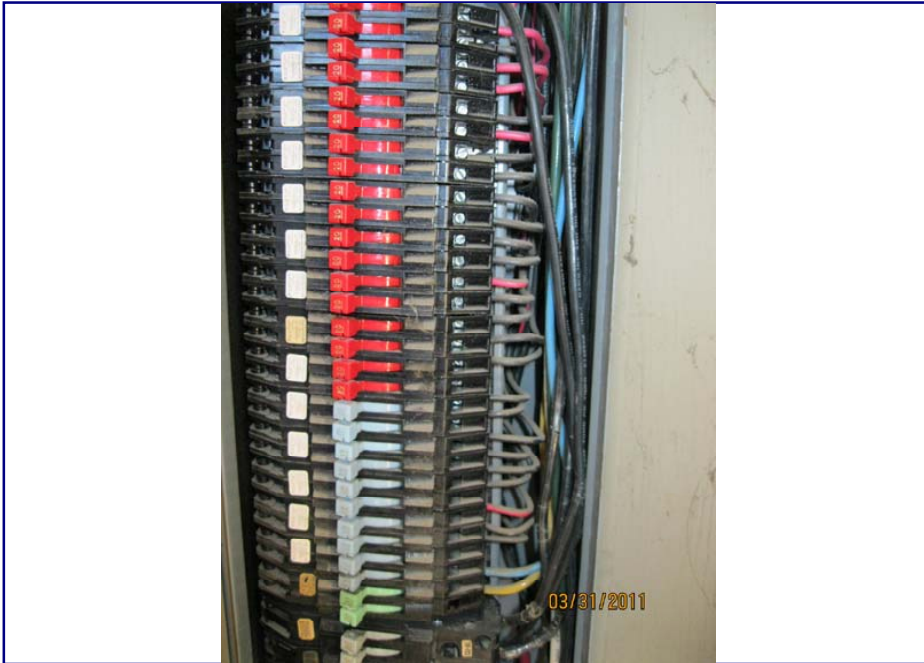
Picture 3

Quality of wire product and craftsmanship is excellent.

These overcurrent breakers are manufactured by the Sylvania / Zinsco group and are the subject of national recall by the US CPSC. See safety flyer attached.

Recommend further evaluation and repair as necessary by licensed electrician as well as repair of garage wall GFCI outlet.

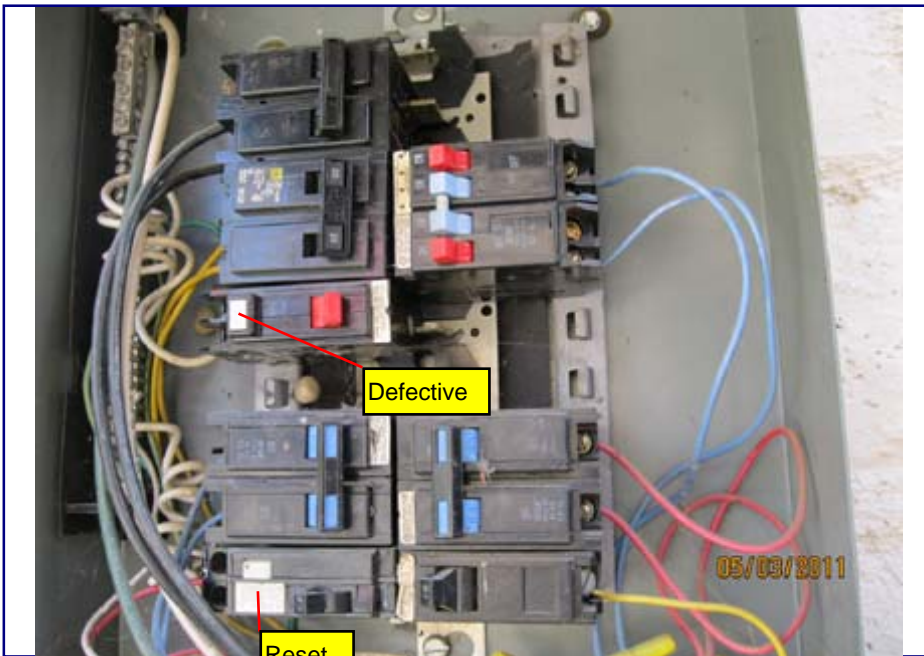
Picture 4

Subpanel at pool enclosure is equipped with 2 ea. GFCI circuit breakers. Breaker at lower left is weak and was reset to operate pool lights. Breaker at center left is defective and may control spa body lights, which were not in operation at time of inspection. Recommend further evaluation and repair as necessary by licensed electrician.

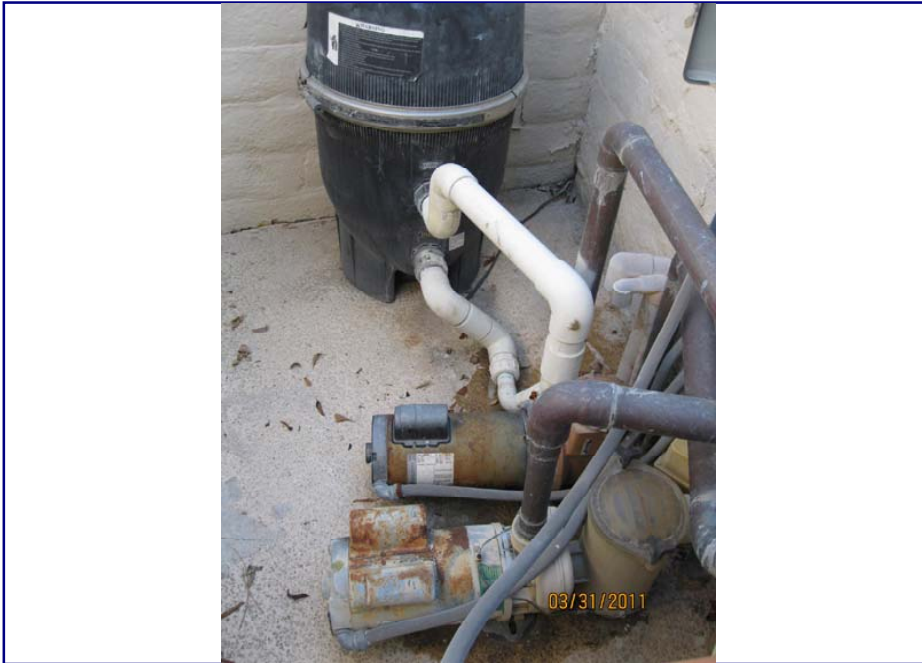
Picture 5

Home is equipped with 2 full filtration systems--one for main pool and one for spa / water feature. All of equipment is original design and should be scheduled for replacement based on age. Neither of heaters is in operational condition. Timers are missing wire covers. South filter is due for cleaning. Recommend maintenance as necessary by licensed pool technician.

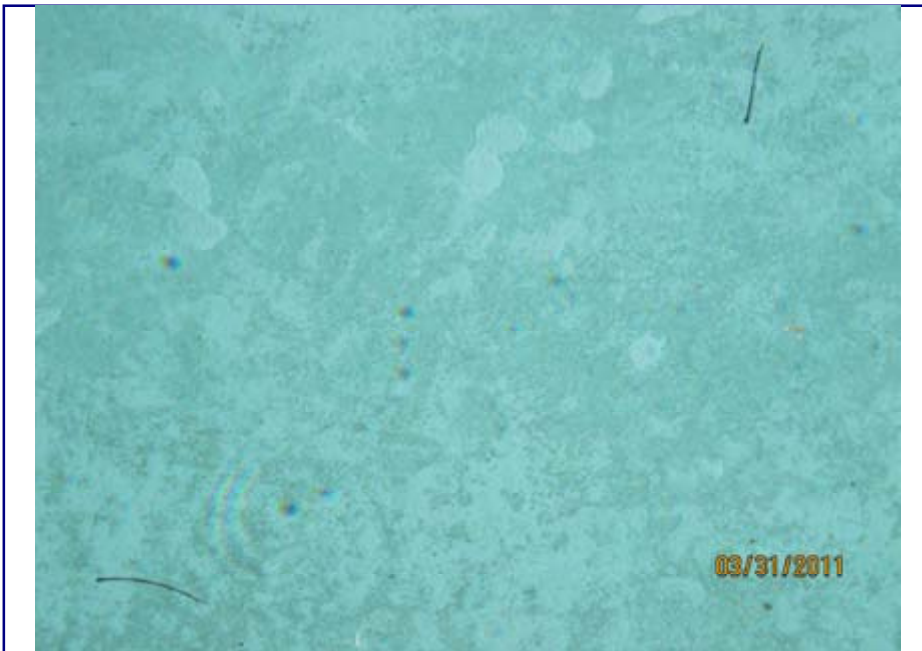
Picture 6

Plaster surface of pool and spa are beginning to peel and spall at multiple locations. Recommend budget for remodel based on age and condition. Significant cracks are noted at random pool deck surface areas. Pool fill is manual. Pool is overfilled at time of inspection. In ground spa at rear deck is scheduled for removal.

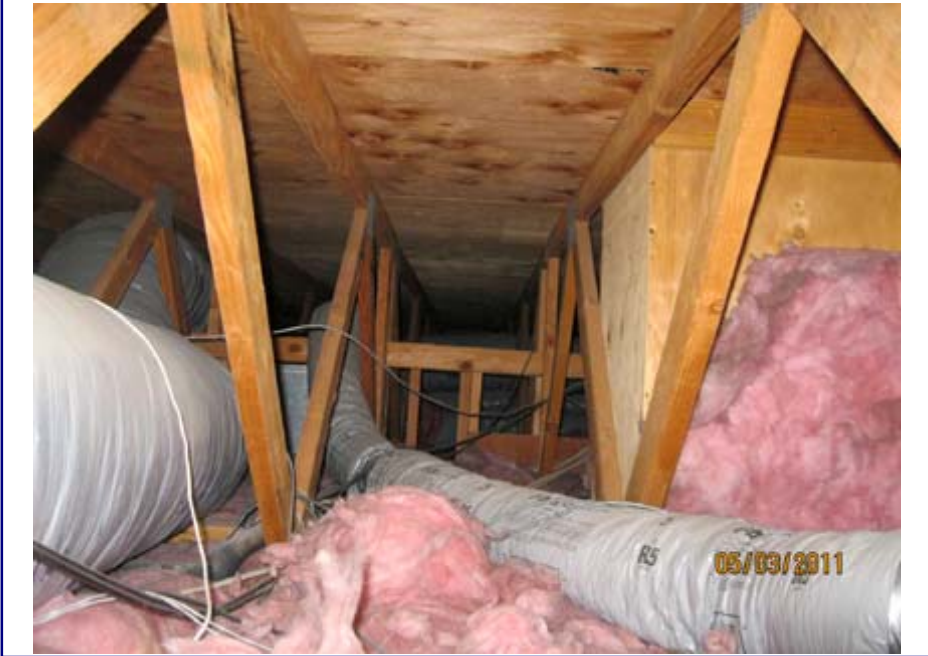
Picture 7

Roof framing, ventilation, insulation, and duct work are installed to conform with prevailing standards. Insulation appears to average 6-8 inches of depth.

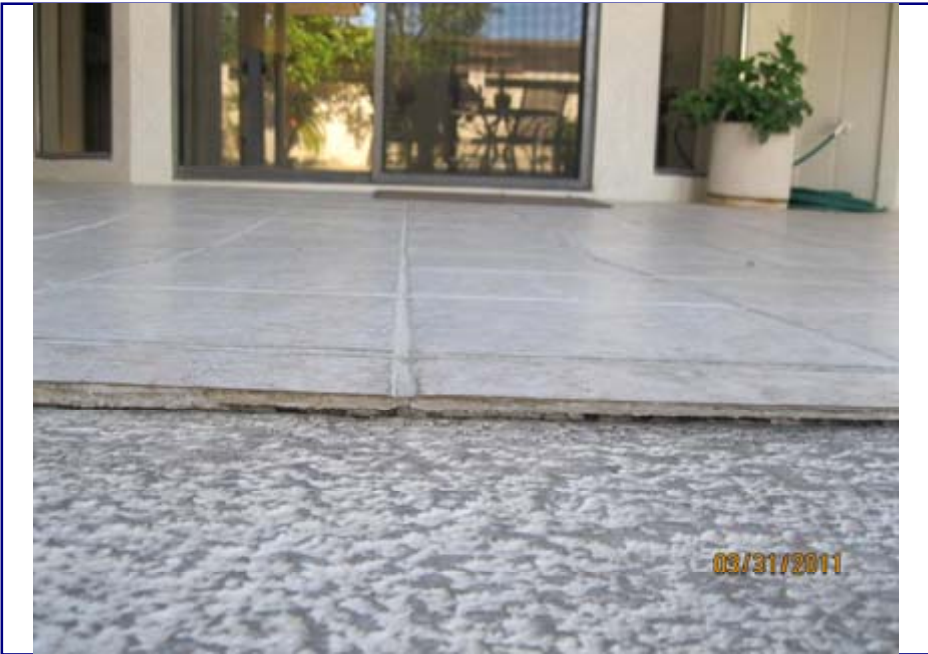
Picture 8

Comments: **Deteriorating grout joint is noted at tile to pool deck interface. Recommend practical upgrade as necessary. See photo # 8.**

Grout joint at tile colonnade to pool surface has eroded and may be recognized as a trip hazard. Recommend repair as soon as practical.

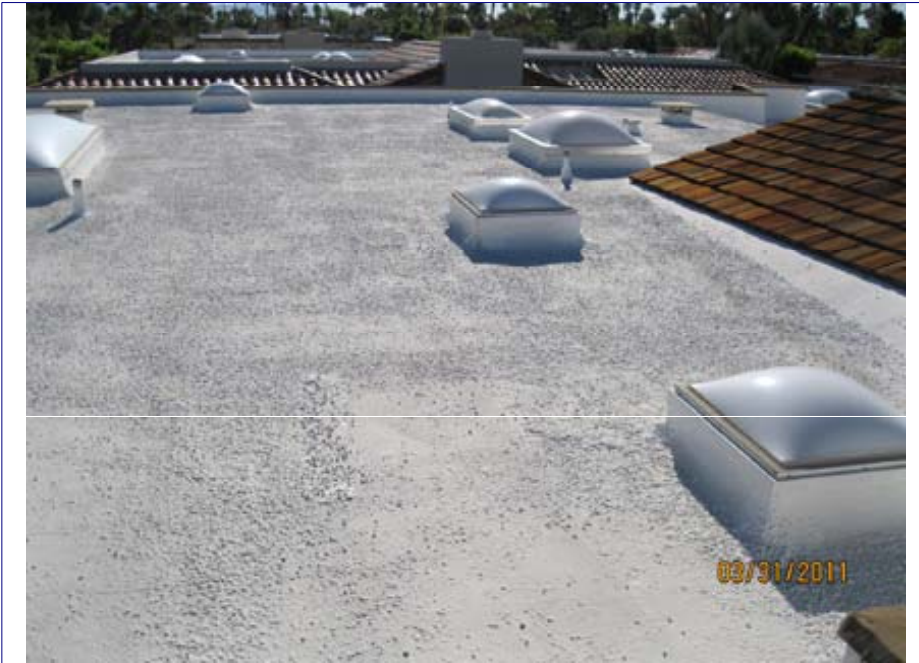
Picture 9

Comments: **Roof material, flashings, sky lights, and vents are in competent condition at time of inspection. The roof is a combination of UV resistant sealer over built up bitumen and gables of cedar shake shingles. Shingles are beginning to show effects of age. See photo # 9.**

Roof material, flashings, sky lights, and vents are in competent condition at time of inspection. The roof is a combination of UV resistant sealer over built up bitumen and gables of cedar shake shingles. No significant defect is noted at time of inspection.

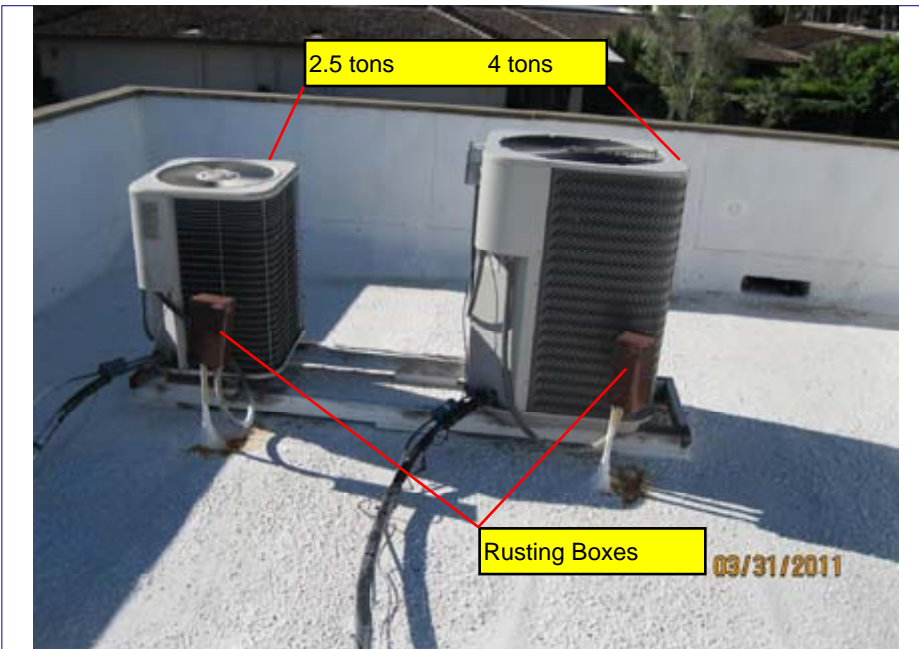
Picture 10

Home is equipped with 6.5 tons of cooling capacity. Both units operate as designed at time of inspection.

Disconnect boxes are not for outdoor use and are bleeding rust on to roof surface. Recommend installation of NEMA-4 enclosure or exterior equivalent.

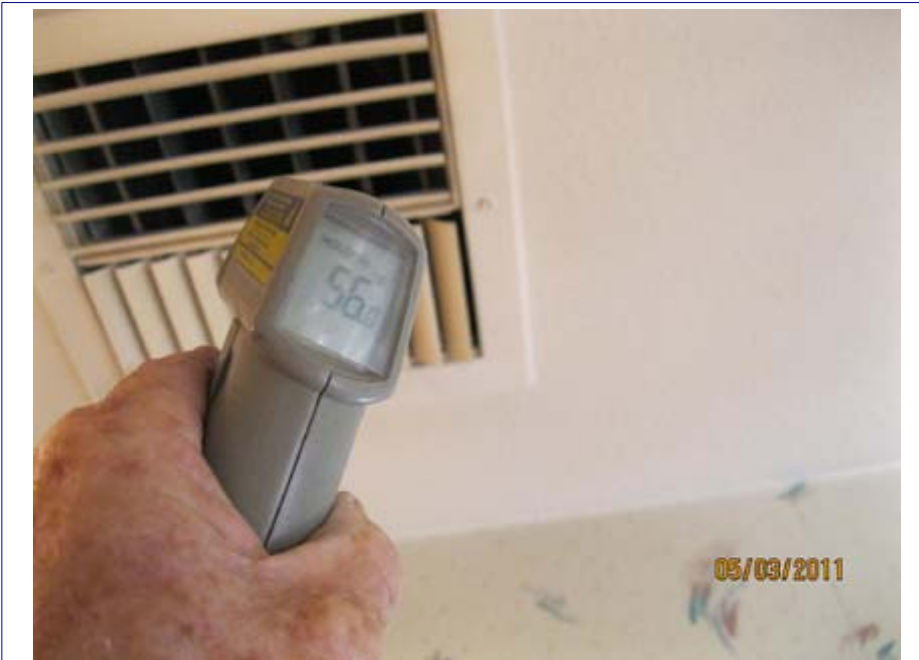
Picture 11

Comments: **Inspector measured register outputs at 105-115 degrees in heat mode and 54-60 degrees in chill mode, which are acceptable values for these size of furnace units. Recommend seasonal service prior to extended use.**

Inspector measured register outputs at 105-115 degrees in heat mode and 54-60 degrees in chill mode, which are acceptable values for these size of furnace units. Recommend seasonal service prior to extended use.

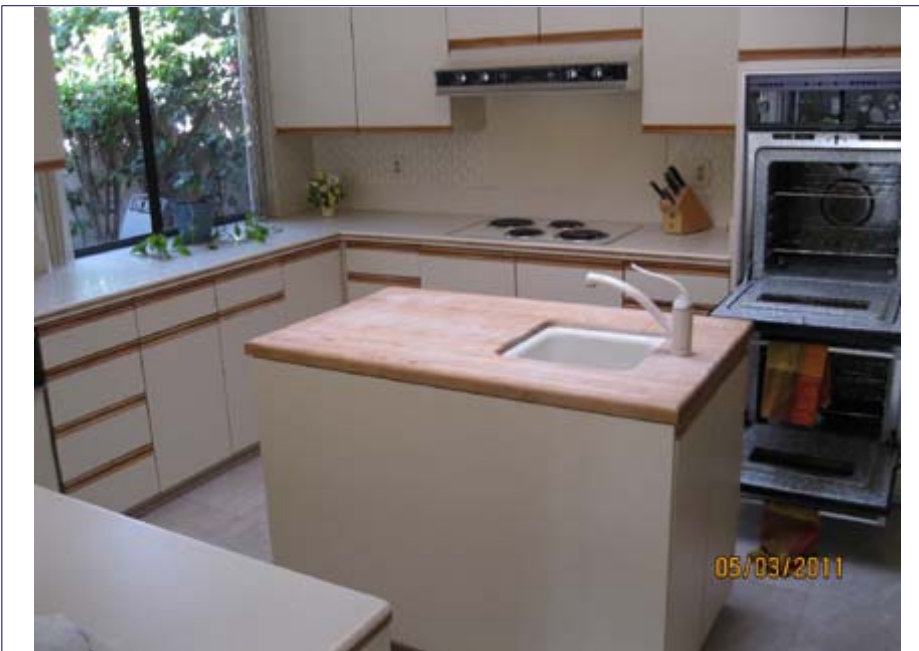
Picture 12

Kitchen appliances were tested and found to be in competent working condition at time of inspection.

Dishwasher is loose in cavity. Recommended anchoring as necessary.

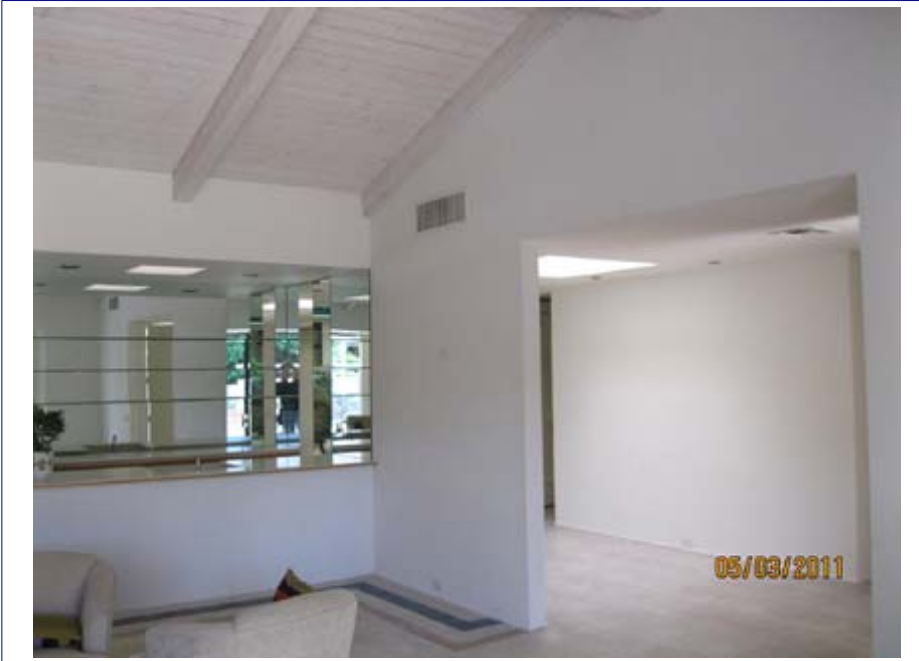
Picture 13

Interior wall, floor, and ceiling coverings are generally fresh and professional at time of inspection.

Home is equipped with interior water feature that did not appear to be in operation at time of inspection.

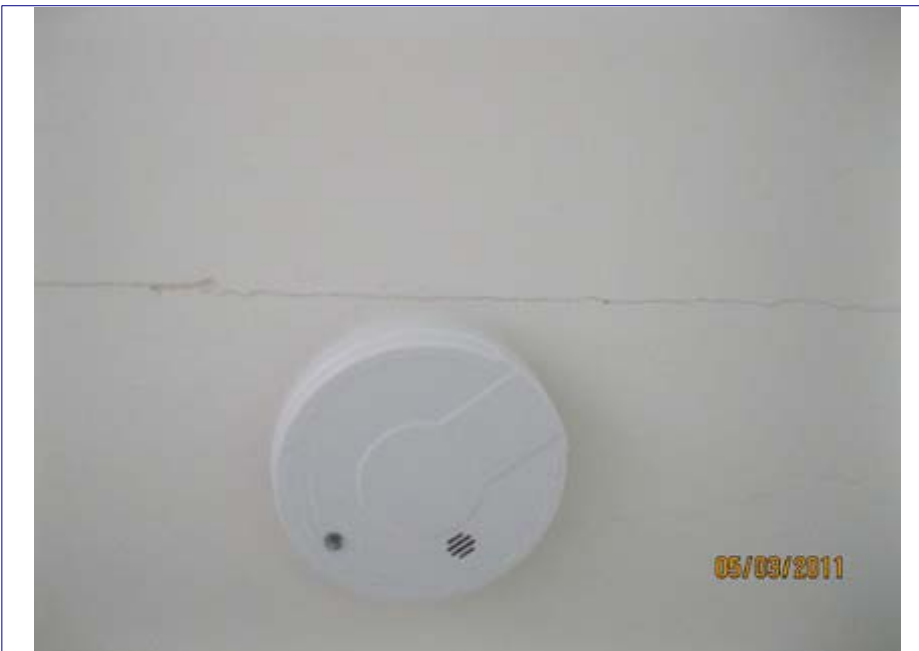
Picture 14

Minor settlement cracks are noted at drywall seams in North hall and near corner of hallway closet.
